Successful Warm-Weather Infrared Inspections

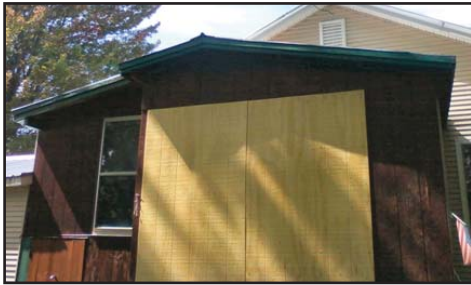
Image 8. Was there missing insulation here?

Instead it turned out to be different colors of siding (painted vs. unpainted wood) as seen in Image 8 from the outside. The darker painted surface absorbed more of the sun's thermal energy, heating up the painted portions of the wall more than the unpainted areas.

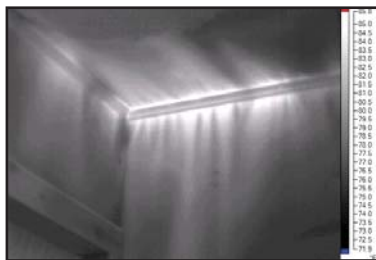
The use of a blower door helps make summer inspections possible.

Typically depressurizing to about 20 Pa is sufficient and provides enough of a draw to move air so its effects can be seen thermally. It can take up to a few minutes (sometimes more) for the pattern to emerge, but as the blower door is running watch for sources of warm air infiltration. This approach certainly works for air leakage and can possibly help reveal insulation patterns that are not seen naturally.
